# CRASH INJURY EVALUATION

U. S. ARMY YHU-1D

BELL IROQUOIS HELICOPTER MOCKUP

REPORT OF CRASH INJURY EVALUATION

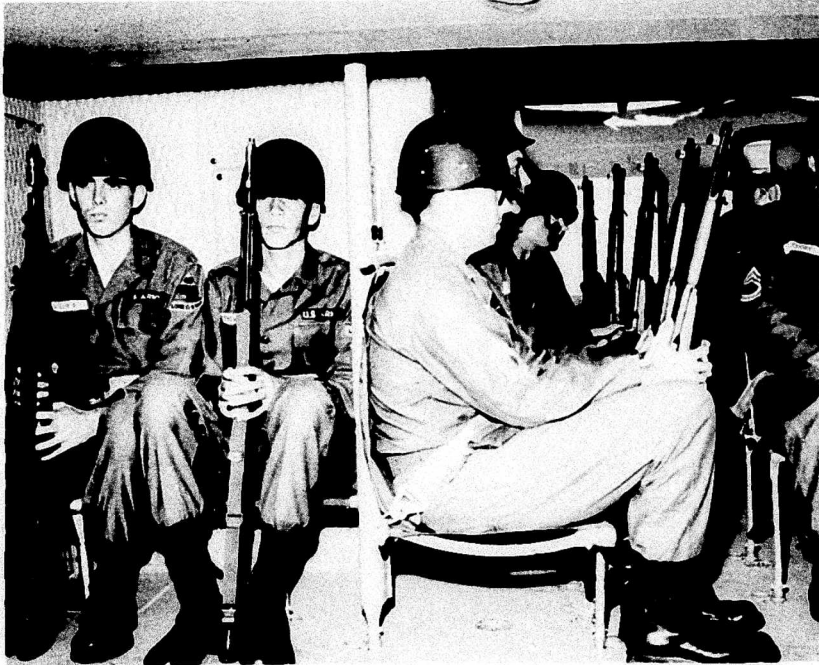
Figure 26. YHU-1D, eleven men seated in cabin (same configuration as illustrated in Figure 25)

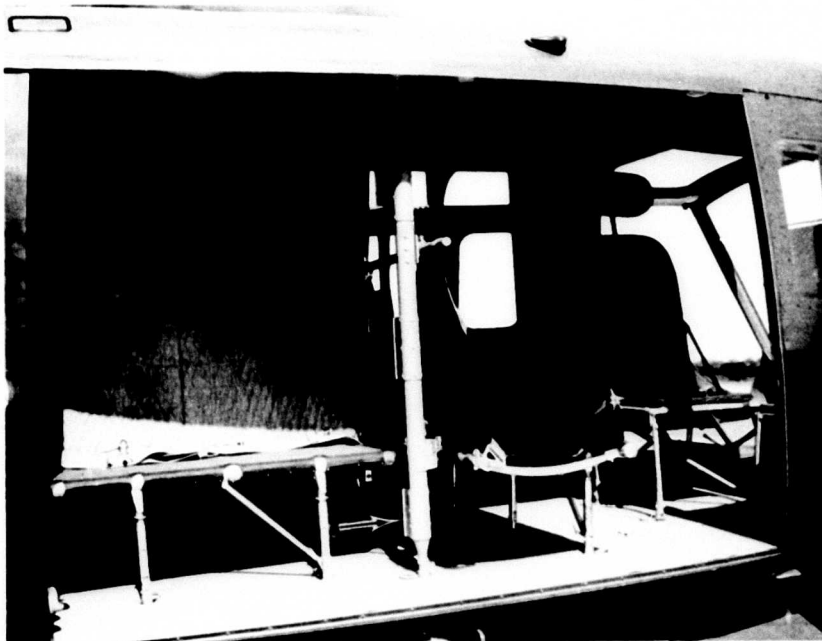
Figure 27. YHU-1D alternate troop seating configuration. Note seat support pole (arrow) which is also to be utilized as a litter pole.

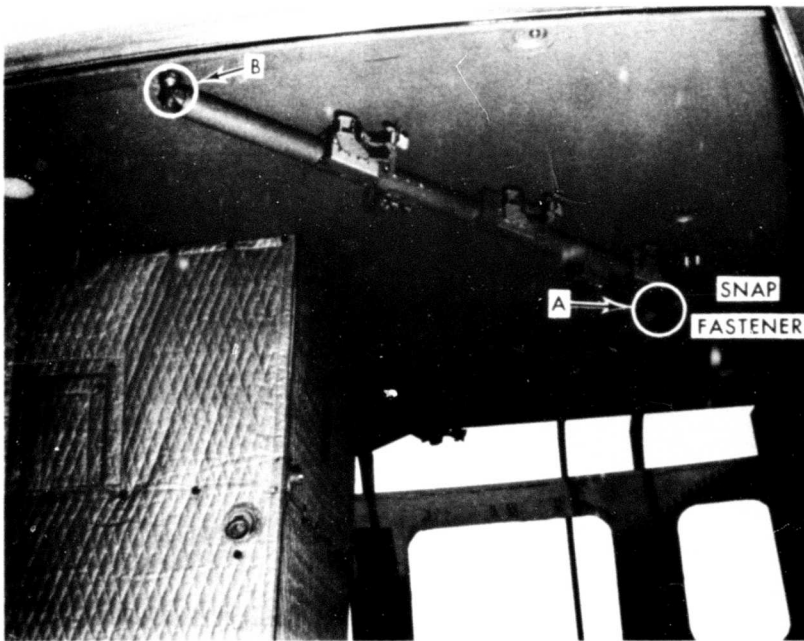
**Figure 29.** YHU-1D litter/seat support poles in overhead stowage. Arrow "A" shows snap fastener, arrow "B" shows pivoted anchorage.

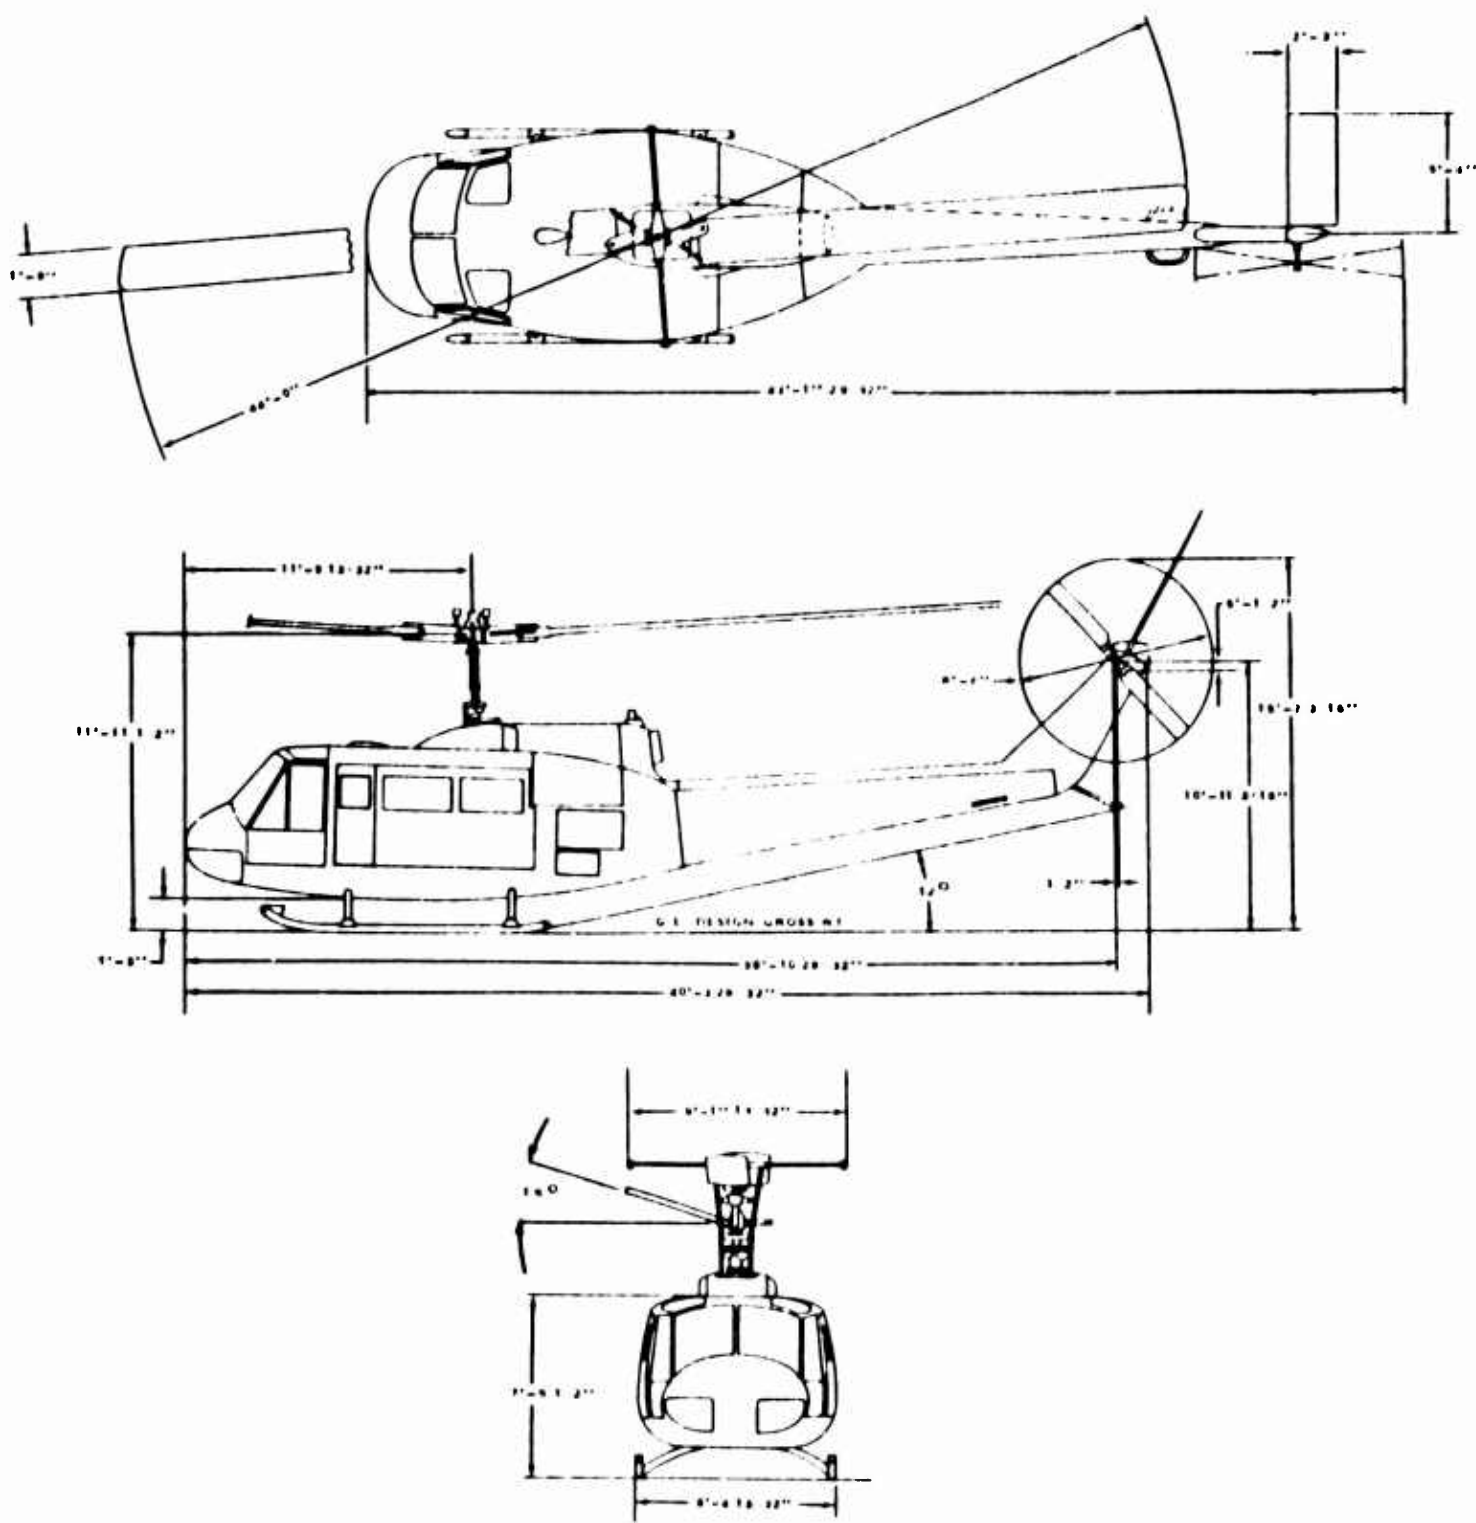
YHU-1D general arrangement and size
